Naval Surface Warfare Center Carderock Division

NSWCCD-50-TR-2007/030 June 2007

Hydromechanics Department Report

Experiment to Characterize Sea Fighter FSF-1 Wave Slamming

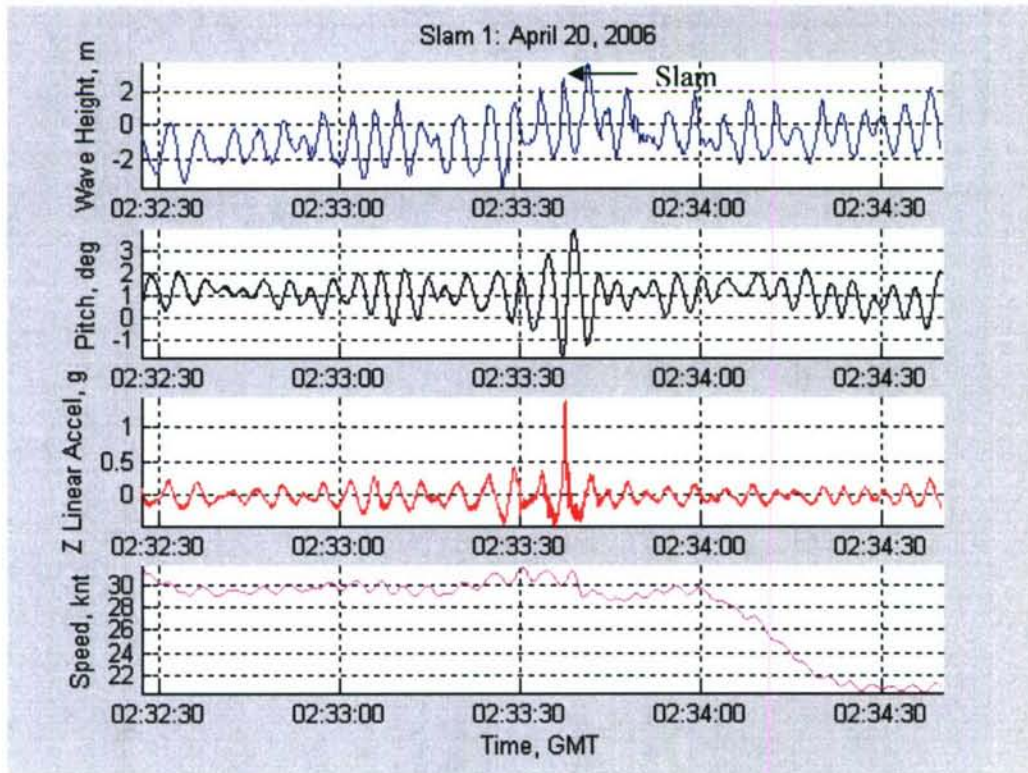
Figure 29. Slam Event 1: Wave Height, Pitch, Vertical Acceleration, and Speed plots.

From Figure 29 it can be seen that the pitch of the ship varies from approximately 0 to 2 degrees and linear acceleration varies from ± 0.2 g's. The wave heights start in a -10 to 0 ft envelope and then shifts up to a ± 5 ft envelope. The slam occurs shortly after 2:33:30 GMT and can be identified on the graph by the sharp spike in z linear acceleration. It involves three consecutive increasing crests, all above the bounds of the 5 ft envelope. The first two crests cause a slam with the second crest producing the most violent slam, as seen by the large spike in vertical acceleration. In addition, during the trough before the second crest the bow of the ship rises out of the water and is suspended in the air just before the second crest slams into the bow. With the second crest the bow pitches down to the minimum pitch angle for this time period, -2 degrees, then quickly pitches up to 4 degrees (the maximum) and pitches down again to 1 degree with the final crest.

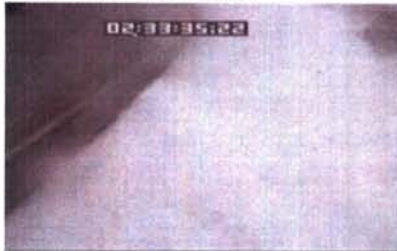
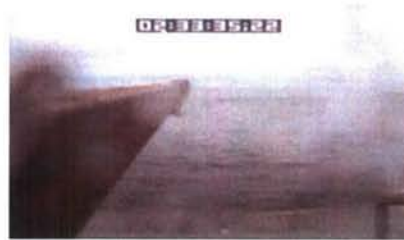
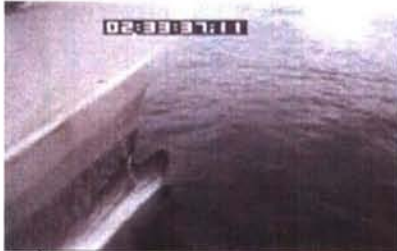
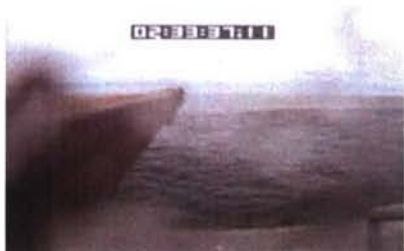
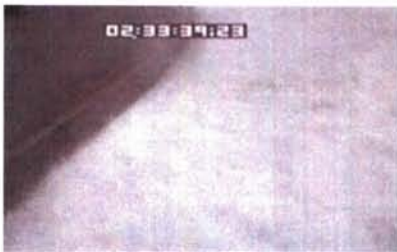
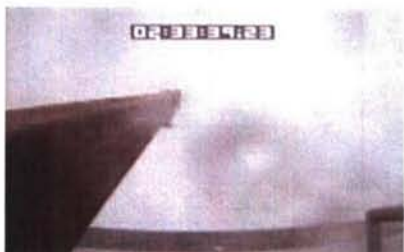
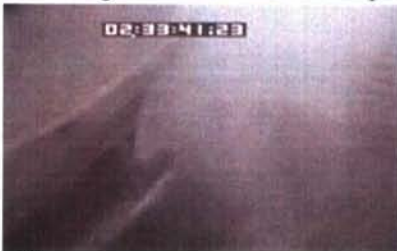
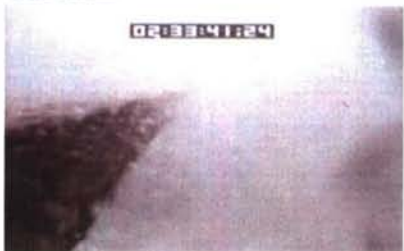
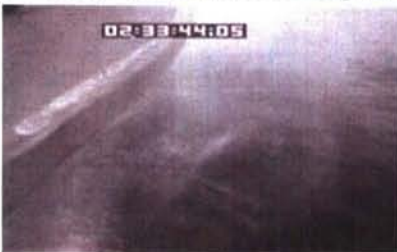
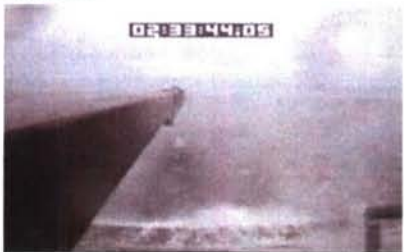
1st crest: Small slam

1st trough: Bow lifts out of water

2nd crest: Slam

2nd trough: White water from previous slam

3rd crest: White water from previous slam

Figure 30. Slam Event 1: Snapshots of on-board cameras. The first row shows the small slam due to the first crest and the third row shows the second, more violent slam.

Figure 30 shows this sequence of events using the on-board bow center and starboard cameras respectively. The first row of snapshots show the first crest which causes a small slam, but it is not large enough for white water to be seen by the center

camera. The second row of photos shows the first trough that lifts the bow out of the water just before the second slam. The third row shows the second crest slamming into the bow, which is the most violent slam of the three crests. The intensity of the slam can be seen by the large amount of whitewater in the bow camera view in both the third and fourth row photos. The fourth row shows the following trough and the remnants of the previous slam can still be seen by the white water and spray that is still present in the bow center camera. The last row shows the last crest which is the largest crest in the wave height plot, but it does not produce a slam.

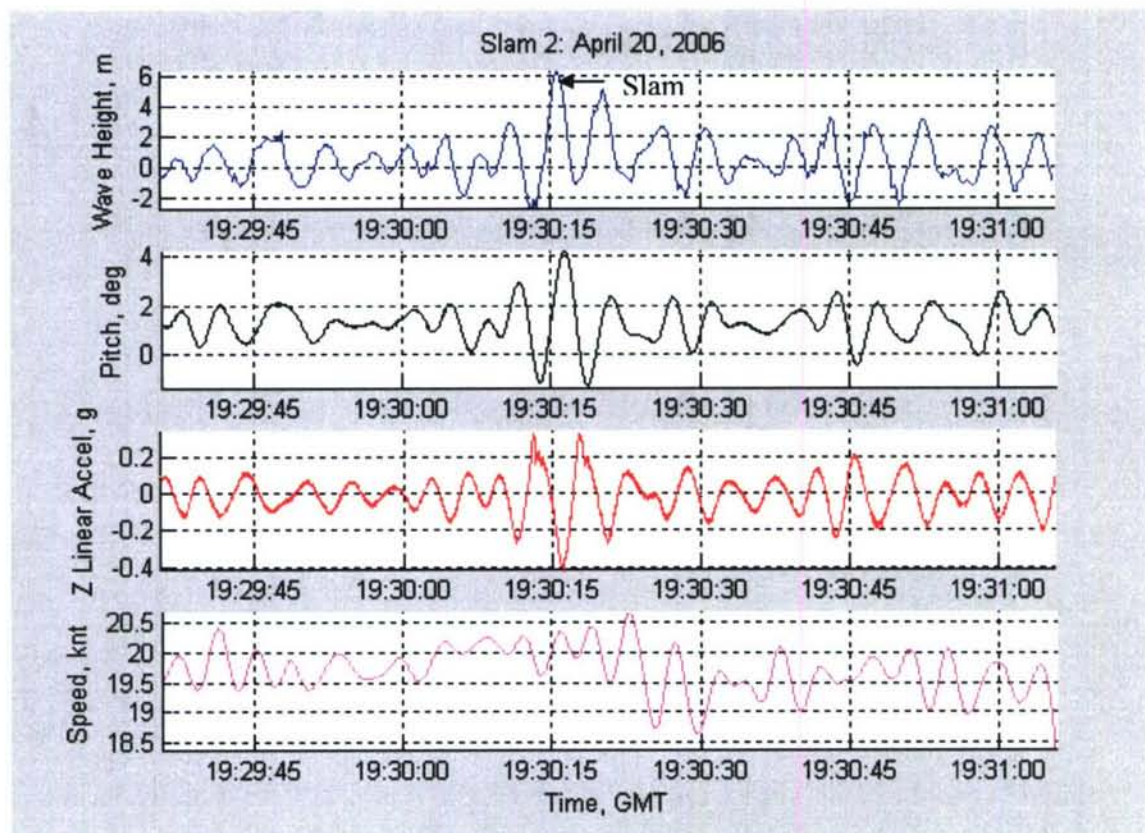
Figure 31. Slam Event 2: Wave Height, Pitch, and Vertical Acceleration, and Speed plots.

The event begins with a 5 ft wave trough which is followed by a 20 ft crest, a trough of 2 ft and another large crest over 15 ft. Both troughs cause the bow of the vessel to completely lift out of the water and both crests cause a slam impact with the bow. Figure 32 provides snapshots from three of the on-board cameras (starboard, center, starboard bowline respectively) showing the sequence of events of the slam as described. The first row of snapshots shows the ship encountering the first trough when the bow lifts completely out of the water. Row 2 shows the impact of the first crest and the small slam it causes. The third row shows the second trough and the bow again lifting out of the water. Finally, the fourth row of snapshots shows the larger slam caused by the impact of the second crest.

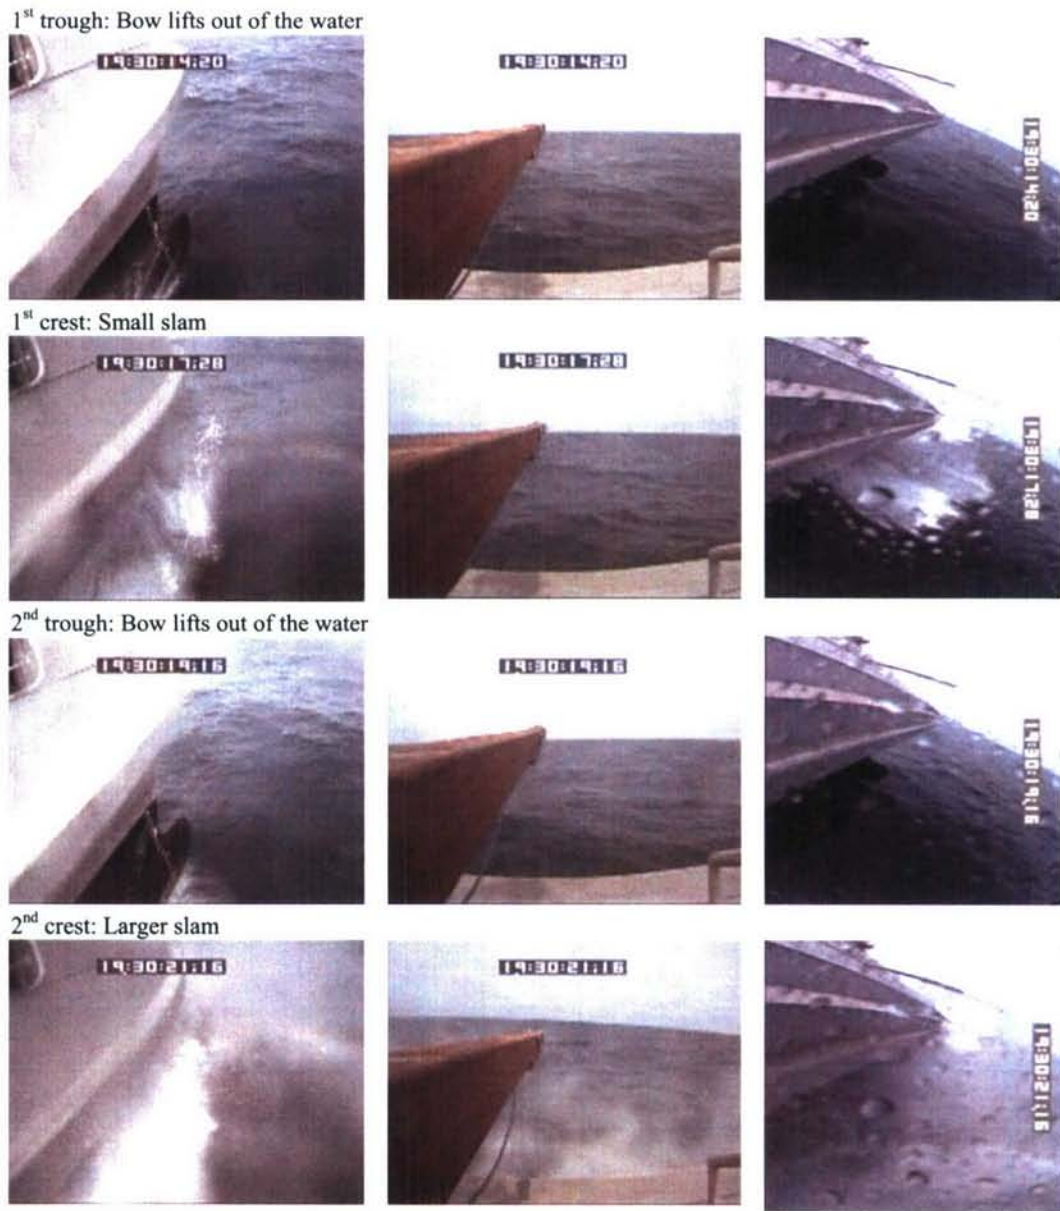
Figure 32. Slam Event 2: Snapshots from on-board cameras.

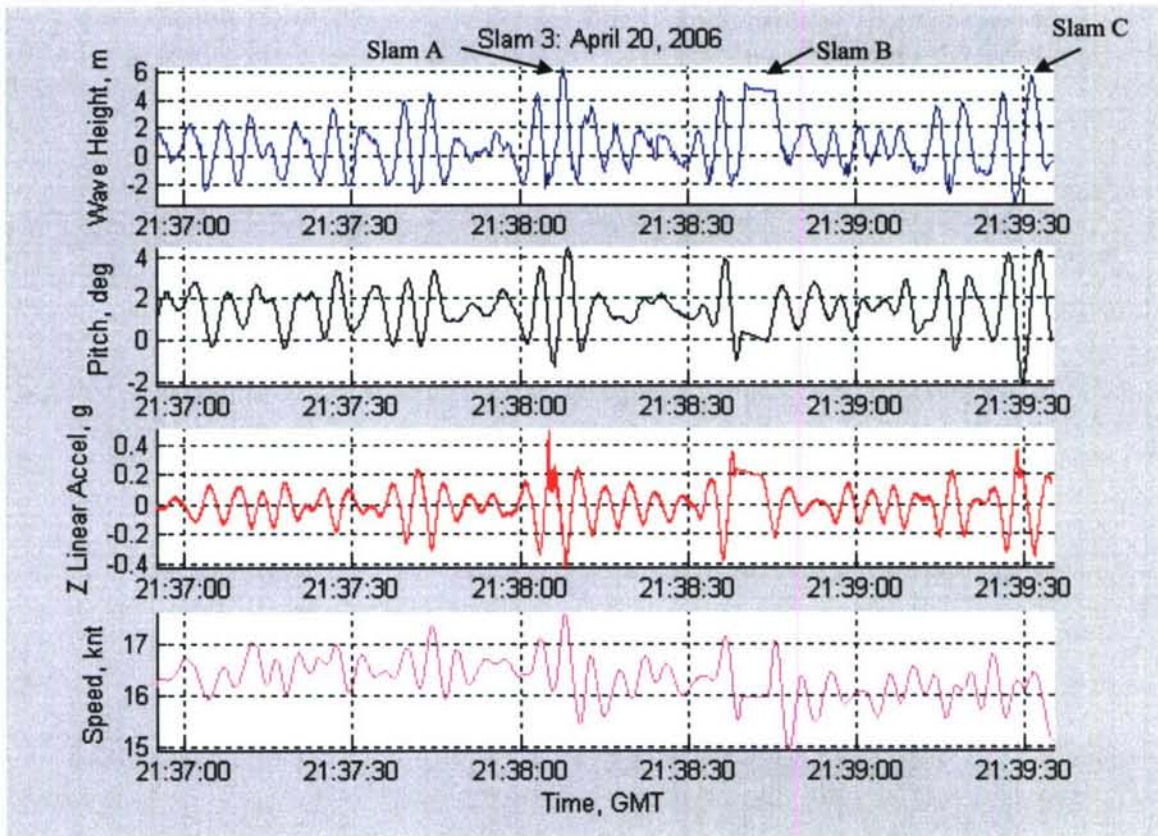
Figure 33. Slam Event 3: Wave Height, Pitch, Vertical Acceleration, and Speed plots.

The most significant slam is Slam A which occurs at approximately 21:38:00 GMT. It begins with a large crest of almost 15 ft followed by a trough of about 8 ft and then a larger crest of over 20 ft followed by another almost 8 ft trough. The slam occurs as the ship encounters the second and larger crest which can be seen by the large spike in vertical acceleration up to 0.5 g's. Figure 34 shows snapshots of three of the onboard cameras during the slam event; the starboard, center, and starboard bowline cameras respectively. The first row in Figure 34 shows the first (15 ft) crest and the second row shows how the bow of the ship comes completely out of the water as it encounters the first 8 ft trough. Next, as seen in the third row and fourth rows, the 20 ft crest slams into the bow causing the large spike in vertical acceleration. The second 8 ft trough (fifth row) causes the bow to rise out of the water again; however the next crest is not large enough as seen by the sixth row of snapshots to cause additional slamming.

Figure 37 shows the sequence of events at about 21:37:40 GMT. The plot in Figure 33 indicates that this is a possible slam event since there are two consecutive wave crests greater than 10 ft which is similar to the trend seen in the three previously discussed slams. In addition, as shown by the snapshots in the second row of Figure 37, the wave trough after the first crest causes the bow of the ship to lift out of the water, also similar to the previous slams. However, the second crest is not large enough to make impact and cause a slam, explaining why no significant spike in vertical acceleration or pitch is seen. This is an example of a wave train that is close to the necessary conditions for a slam, but the wave crests are not large enough to cause ship motions outside of the average envelope.

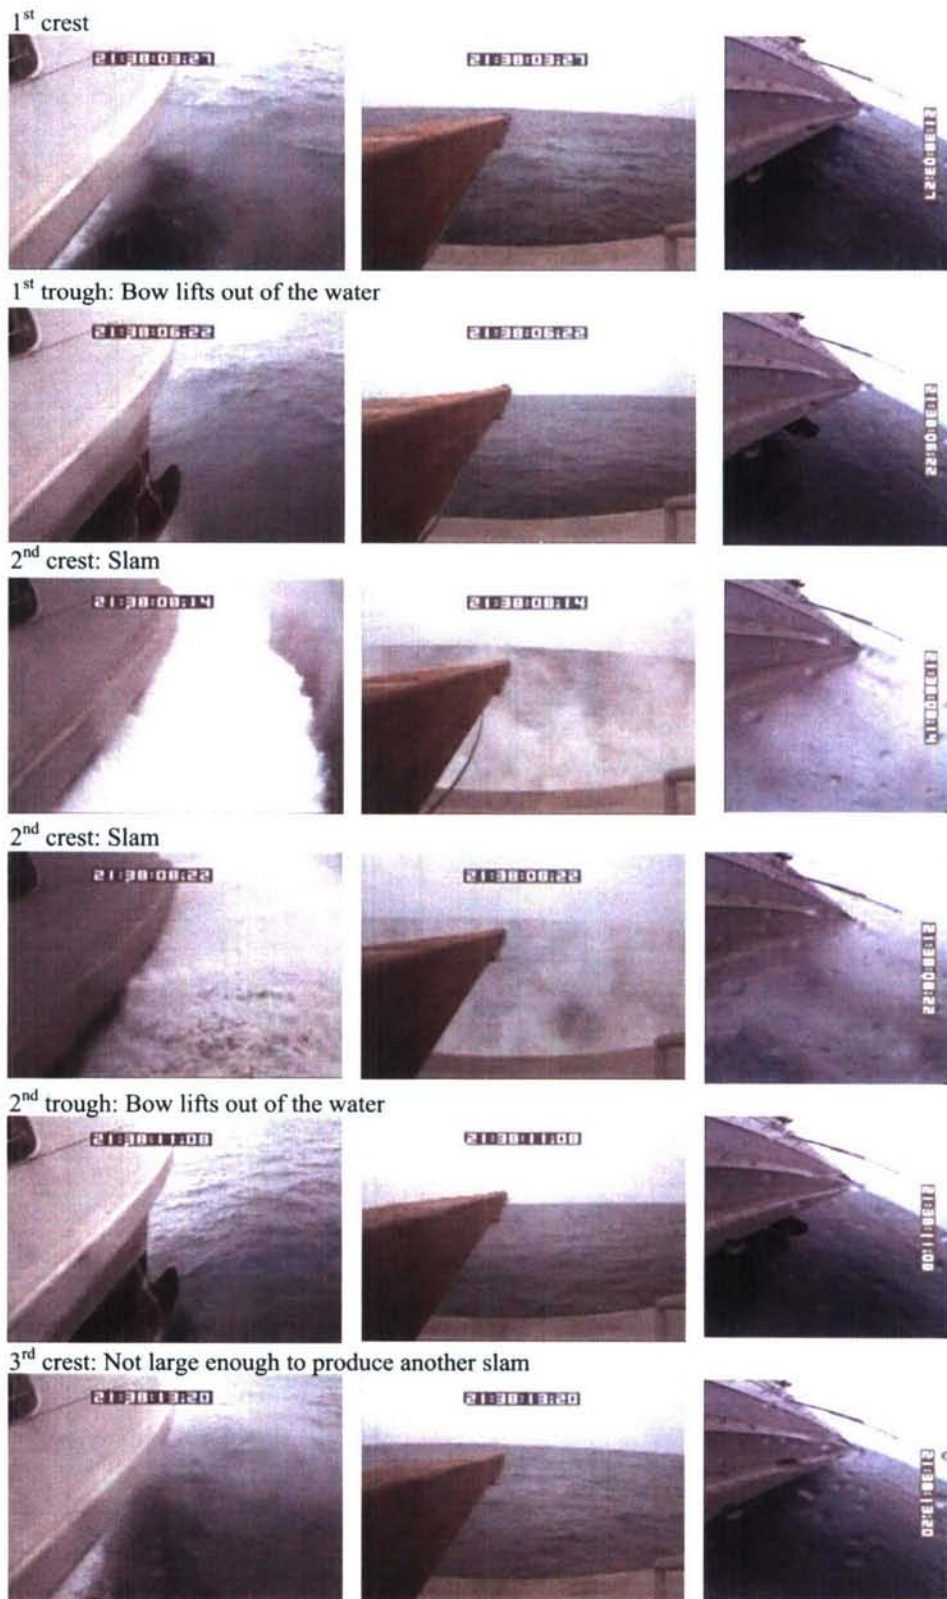
Figure 34. Slam Event 3A: Snapshots from on-board cameras.

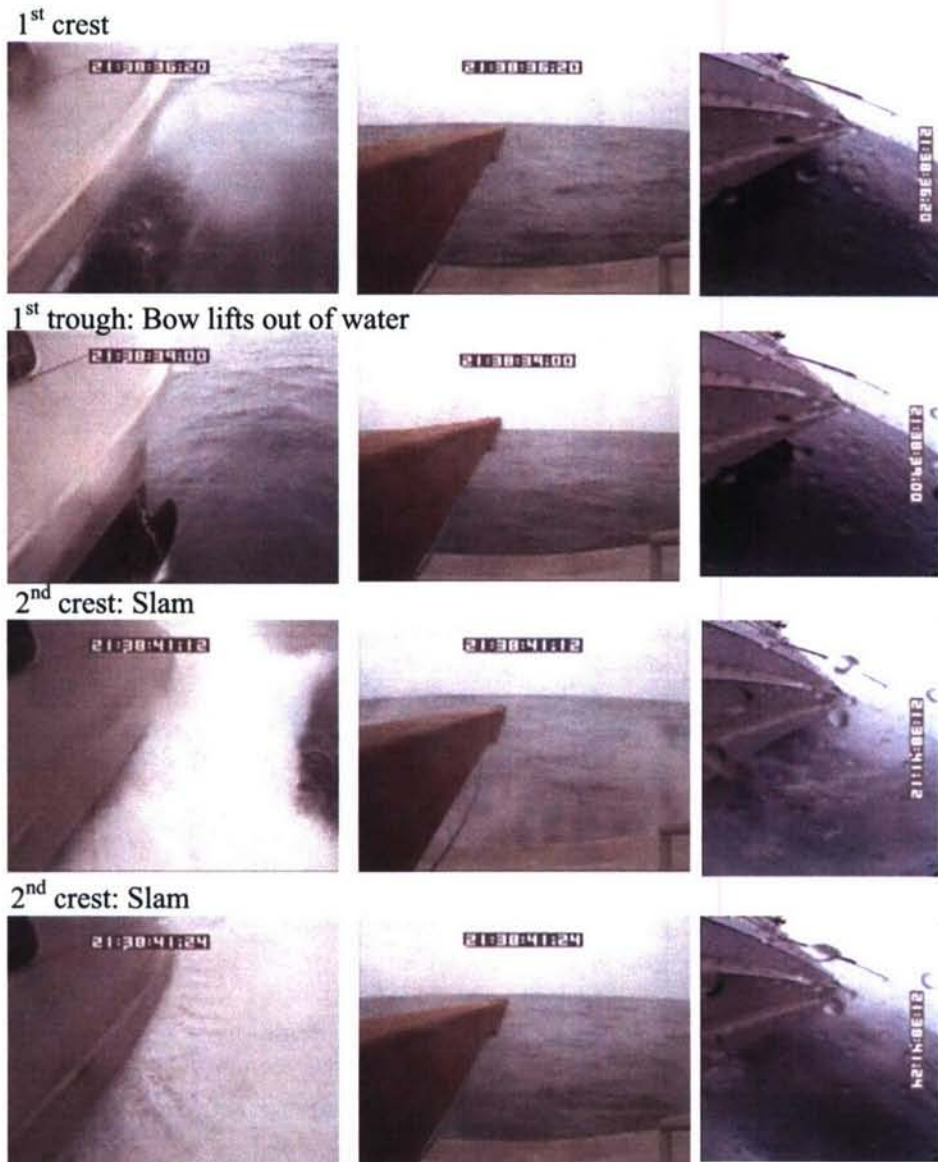
Figure 35. Slam Event 3B: Snapshots from on-board cameras.

Slam B occurs about 45 seconds after the first. Again it begins with a larger than average wave crest of 15 ft followed by an 8 ft trough, and a second slightly larger crest. Unfortunately, at this point the data acquisition program lost its signal and data was briefly lost but the on board cameras were able to visually fill in this data gap. Figure 35 shows this sequence of events. The ship encounters the first crest which comes close to hitting the bottom of the wet deck but is not large enough to cause a slam. The following trough, like the first slam, causes the bow to lift out of the water and pitch up at almost 4 degrees and the second crest is large enough to slam into the bottom of the hull causing the bow to pitch down and an increase in vertical acceleration to almost 0.4 g's.

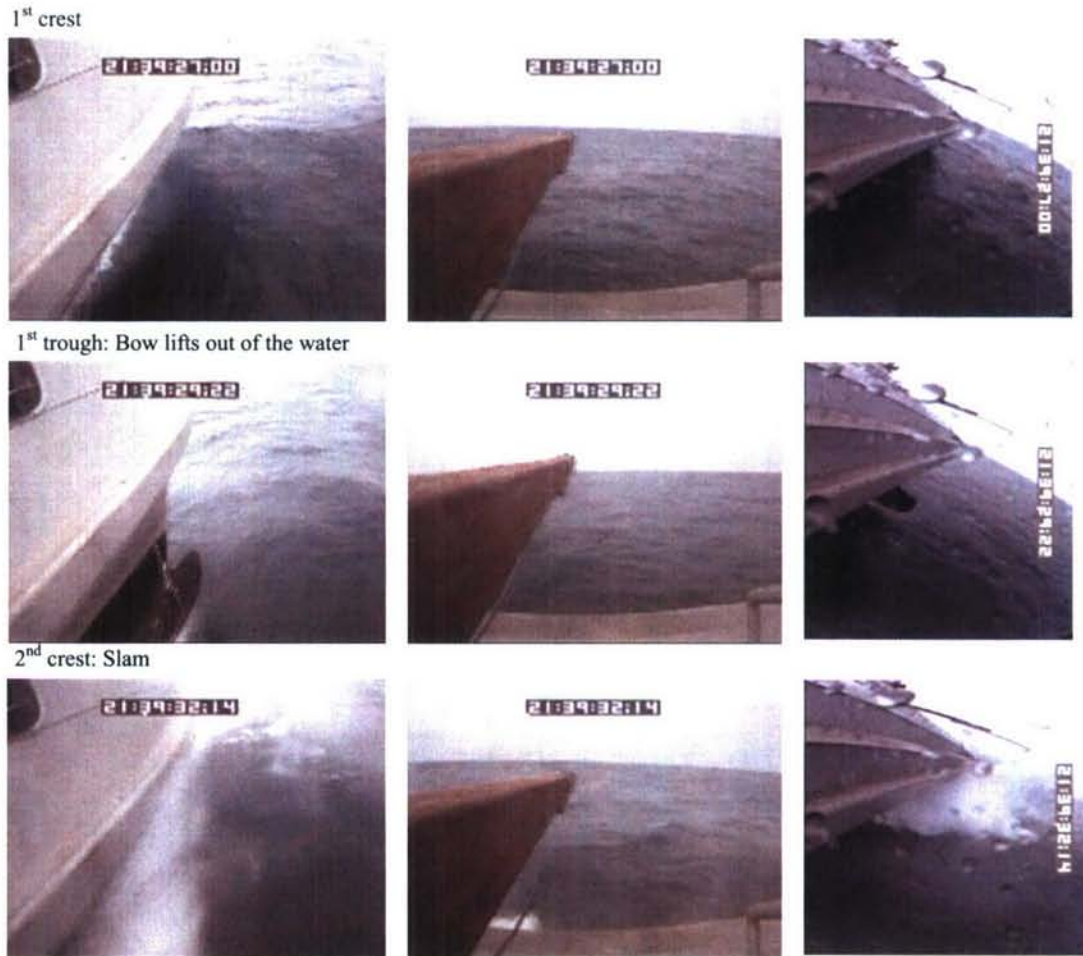
Figure 36. Slam Event 3C: Snapshots from on-board cameras.

The final slam is very similar to the first two. It also begins with a larger than average crest followed by a trough that causes the bow to lift out of the water. The actual slam occurs as the ship encounters the second, and larger, crest which slams into the bottom of the hull in the center tunnel. Figure 36 shows this sequence of events.

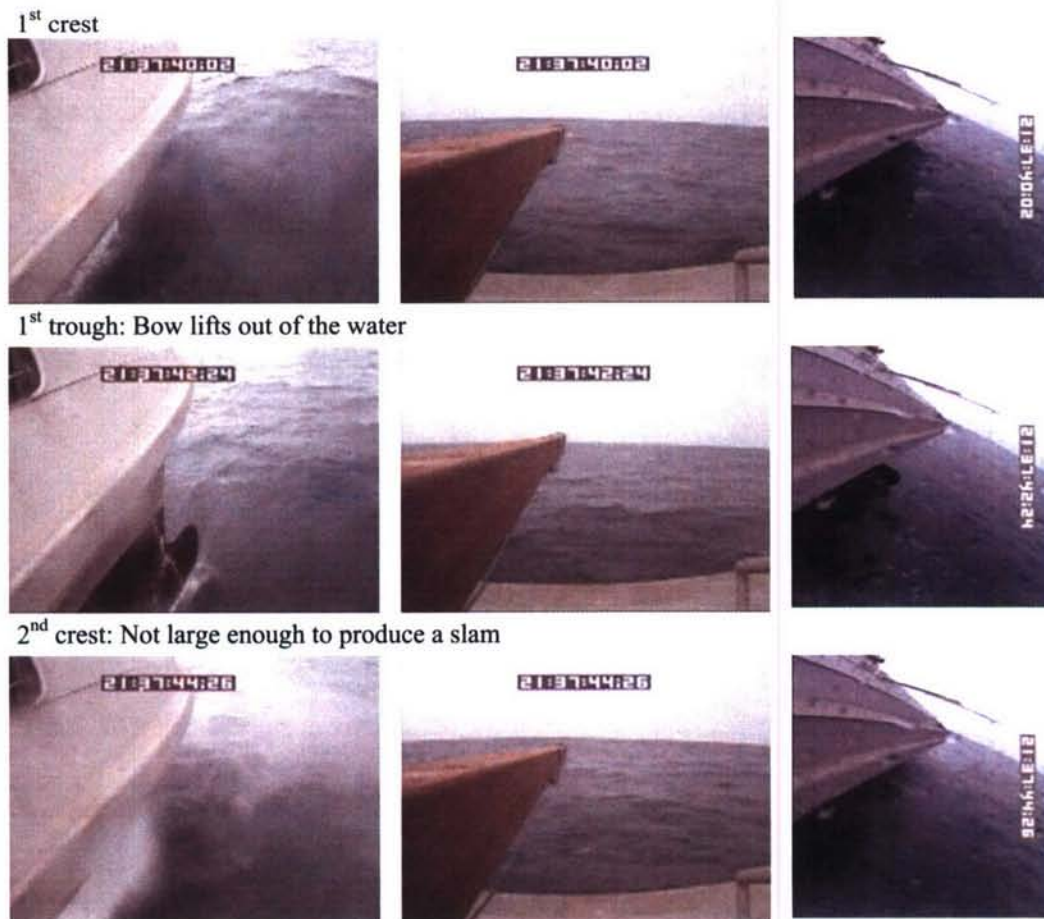
Figure 37. Slam Event 3: Snapshots of near-slam event.

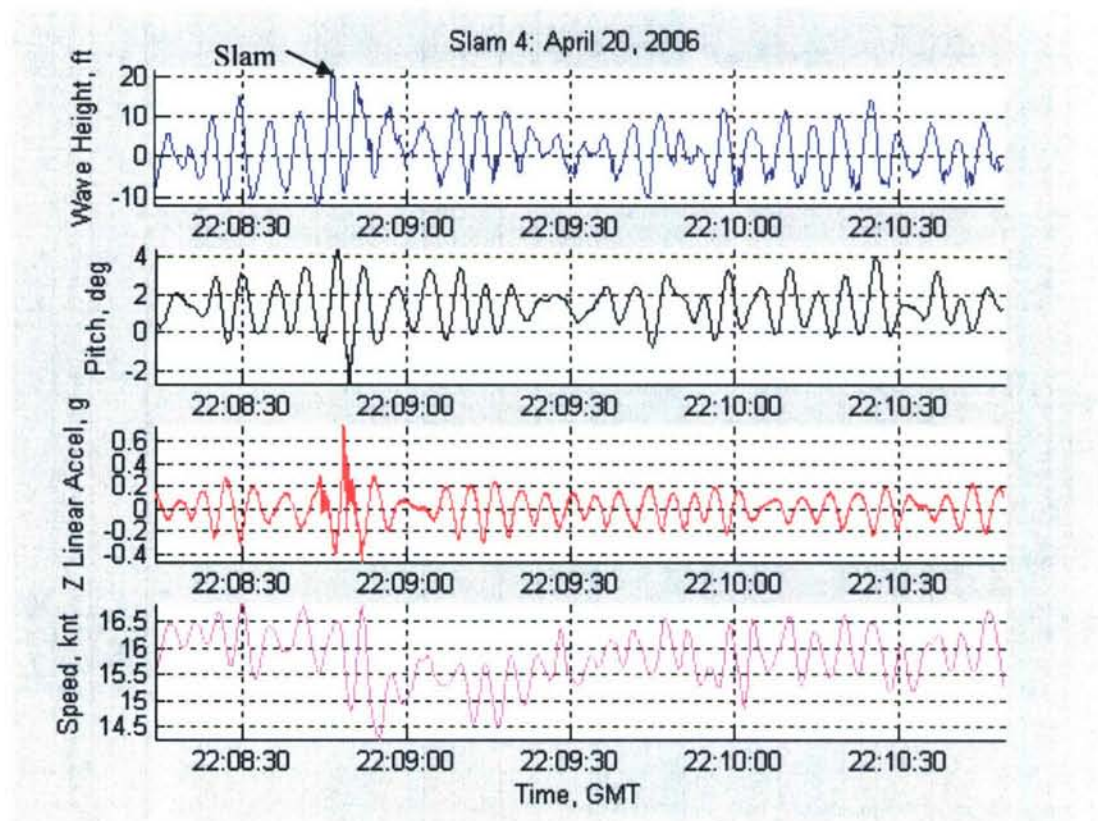
Figure 38. Slam Event 4: Wave Height, Pitch, Vertical Acceleration, and Speed plots.

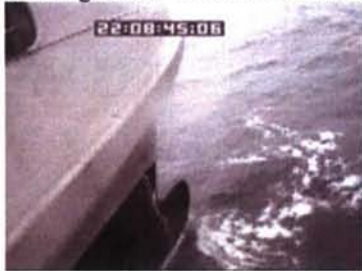
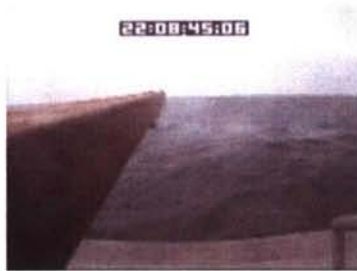
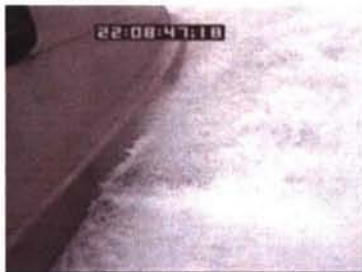
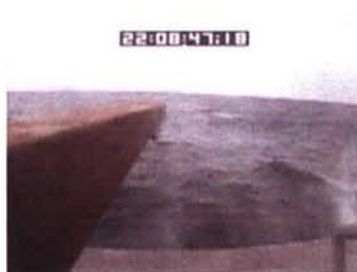
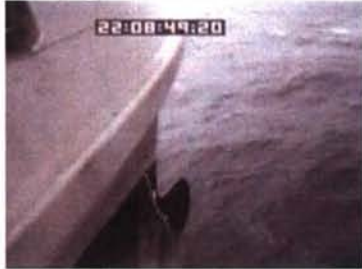
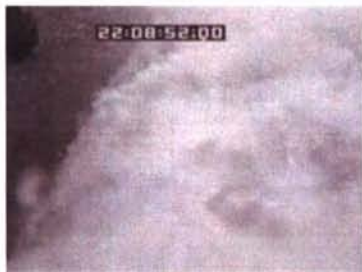
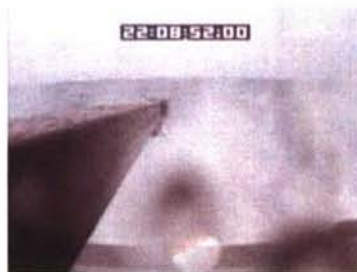
1st trough: Bow lifts out of the water

1st crest: Slam

2nd trough: Bow lifts out of the water

2nd crest: 2nd and more violent slam

Figure 39. Slam Event 4: Snapshots from on-board cameras.

Figure 39 shows snapshots from the starboard, bow center, and starboard bowline cameras respectively during the slam event. With the first trough the bow lifts out of the water and with the following crest there is a slam impact. The bow then rises out of the water again with the second trough and the second crest also slams into the bow, this time more violently than the first as seen by the large amount of whitewater the cameras see and the sharp peak in vertical acceleration seen in Figure 38. With each trough the bow of the ship pitches upward, above the 3 degree boundary of the envelope and downward below zero degrees with each crest. The second crest, which causes the more violent slam, causes the greatest bow down pitch of -2 degrees that is seen which corresponds with the largest spike in vertical acceleration seen in Figure 38. Figure 40 shows a 30-second section of the plots shown in Figure 38 and illustrates how the ship's greatest bow down pitch corresponds with its maximum vertical acceleration.

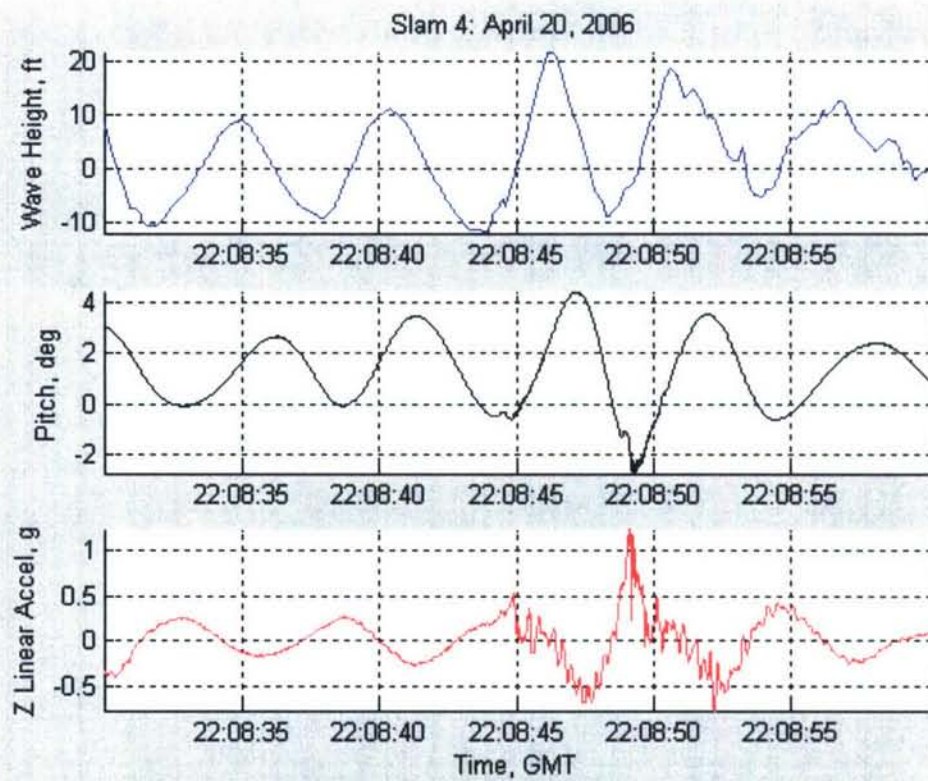
Figure 40. Slam Event 4: 30 second close up plots of slam event.

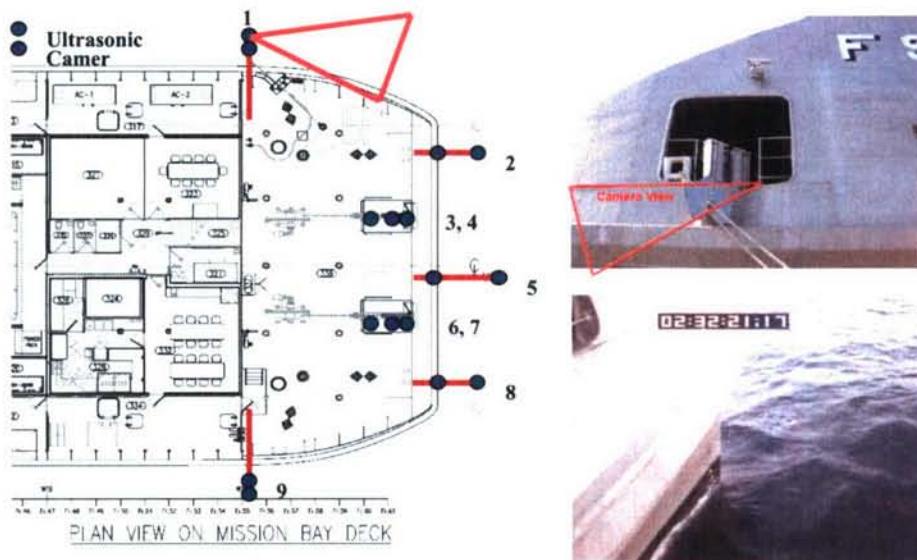
Figure B1. Diagram of view from port bow camera.

An array of nine cameras was deployed to provide qualitative support to the wave measurements. Seven cameras were mounted around the bow of the ship and two more cameras were deployed at the stern (from each hull, looking aft). The cameras were standard color video cameras in waterproof housing operating at 30 frames per second. Figure 4 shows the locations of the bow cameras and Figure B1 - Figure B5 in Appendix B provides details of the camera views.

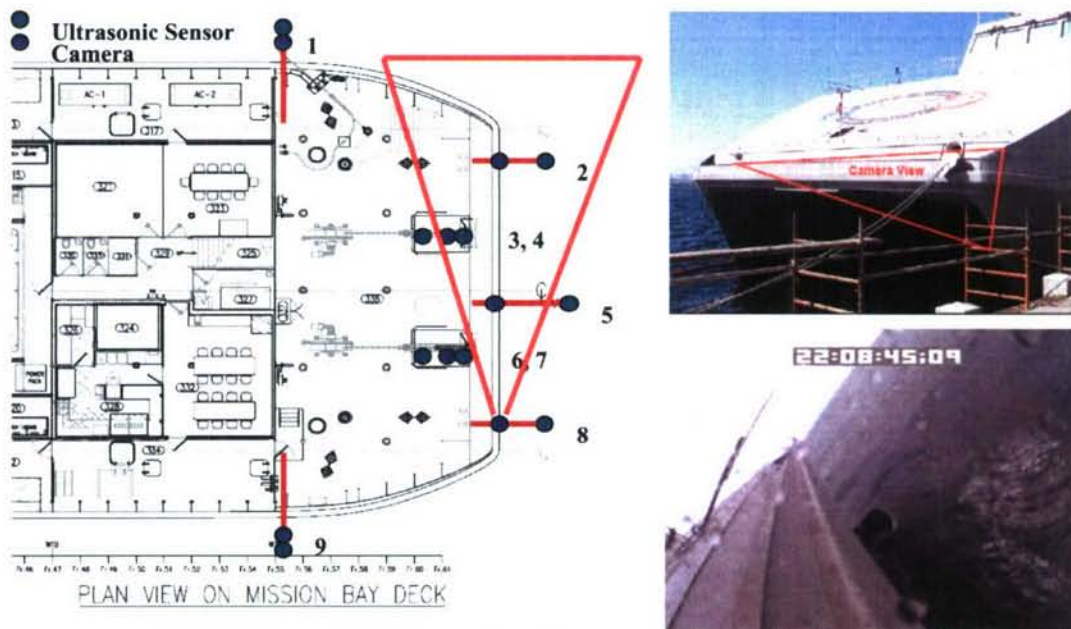
Figure B2. Diagram of view from starboard bowline camera.

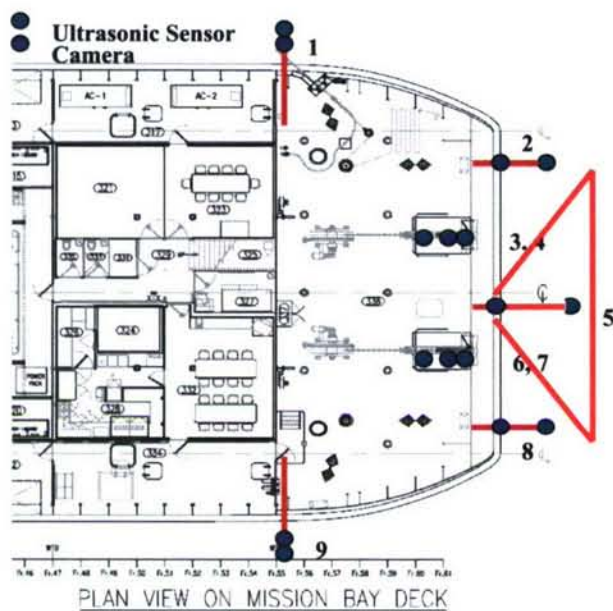
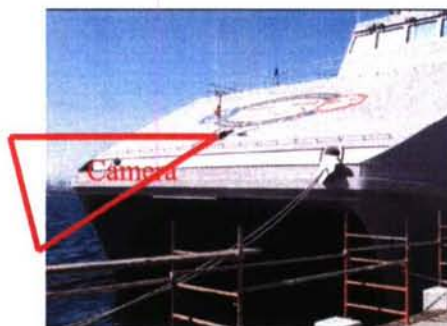
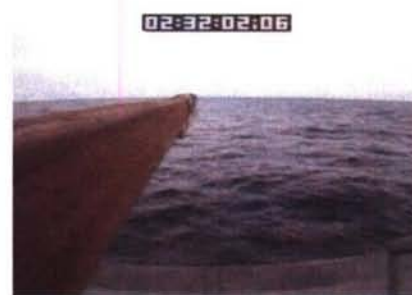
Figure B3. Diagram of view from center bow camera.

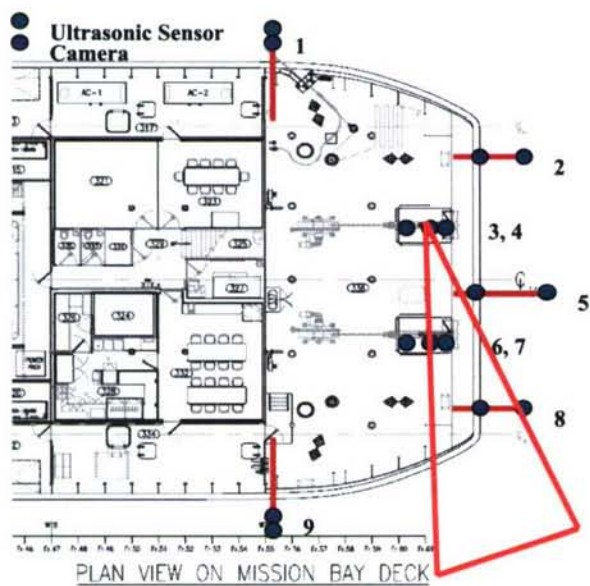
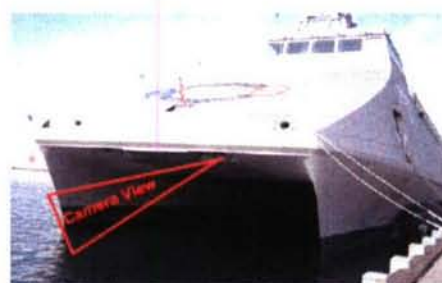
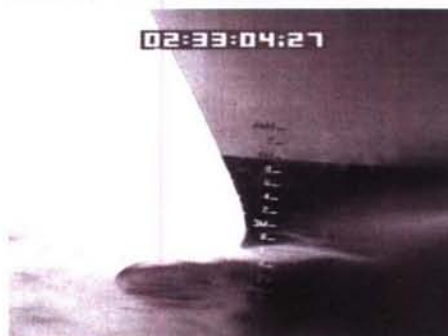
Figure B4. Diagram of view from port anchor well camera.

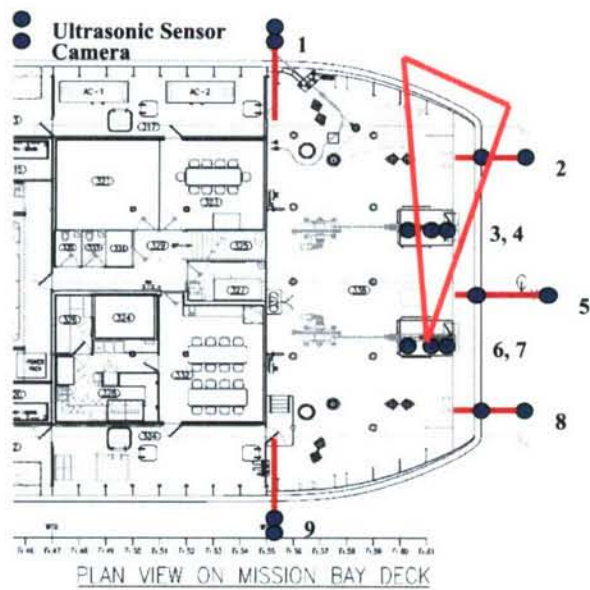
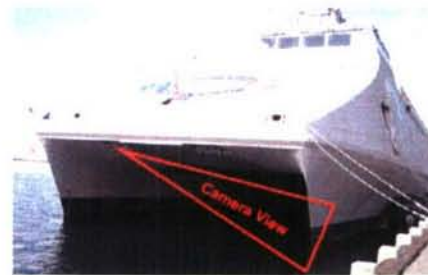
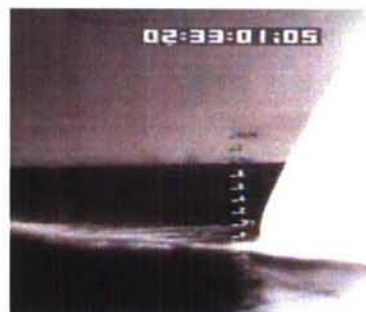
Figure B5. Diagram of view from starboard anchor well camera.

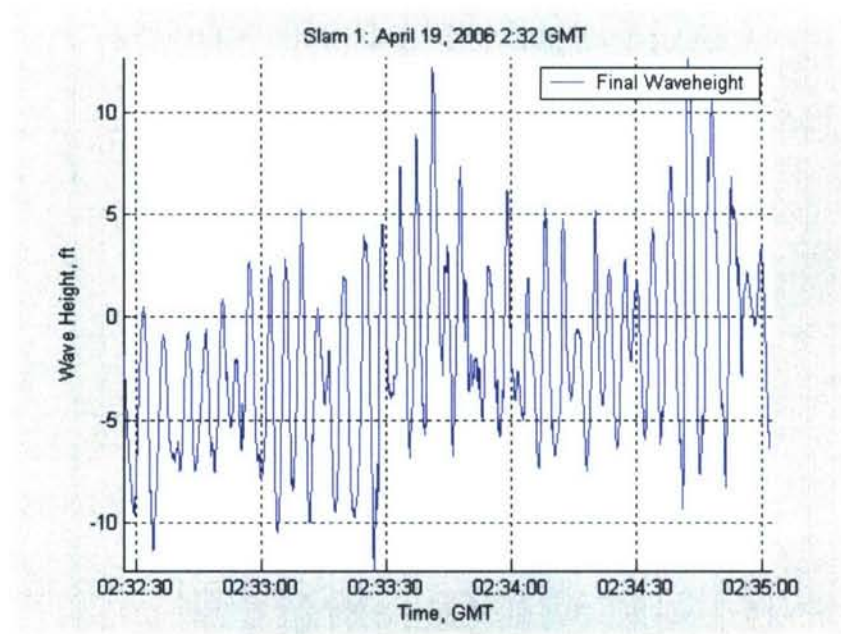
Figure C1. Slam Event 1: Final Wave Profile.

This approach of comparing sensors to one another and determining an average profile for a given bow location was then used in determining the overall average wave field for each slam event. The final wave field for each slam event is shown in Figure C1- Figure C4 in Appendix C.

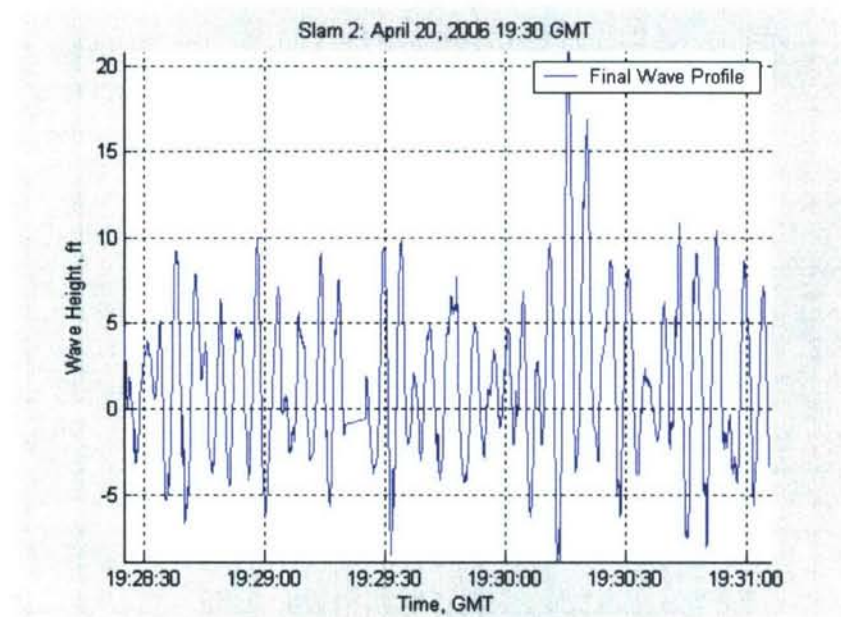
Figure C2. Slam Event 2: Final Wave Profile.

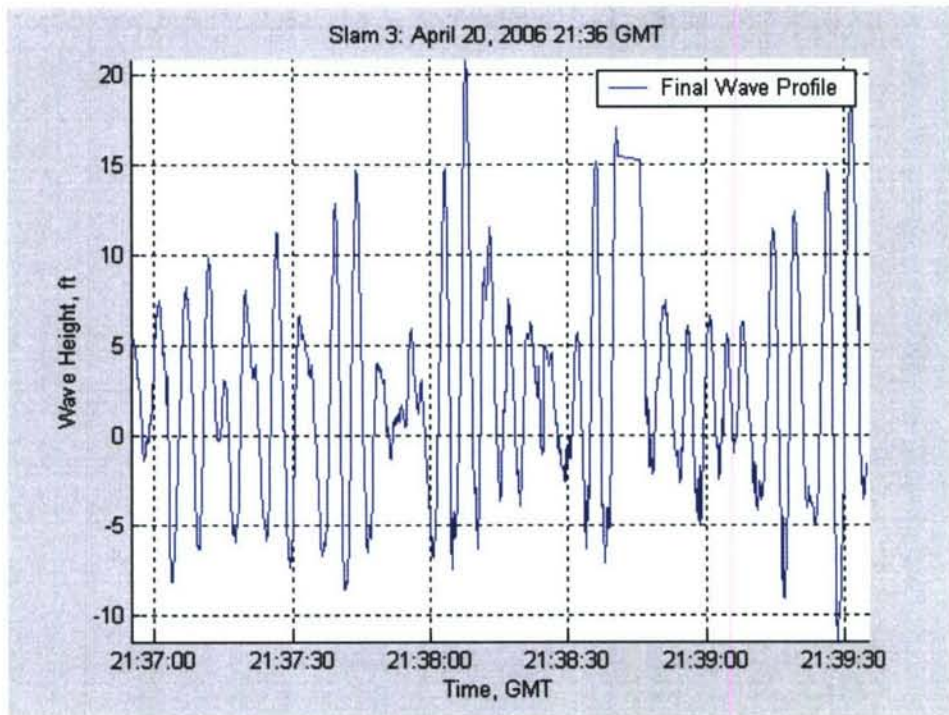
Figure C3. Slam Event 3: Final Wave Profile.

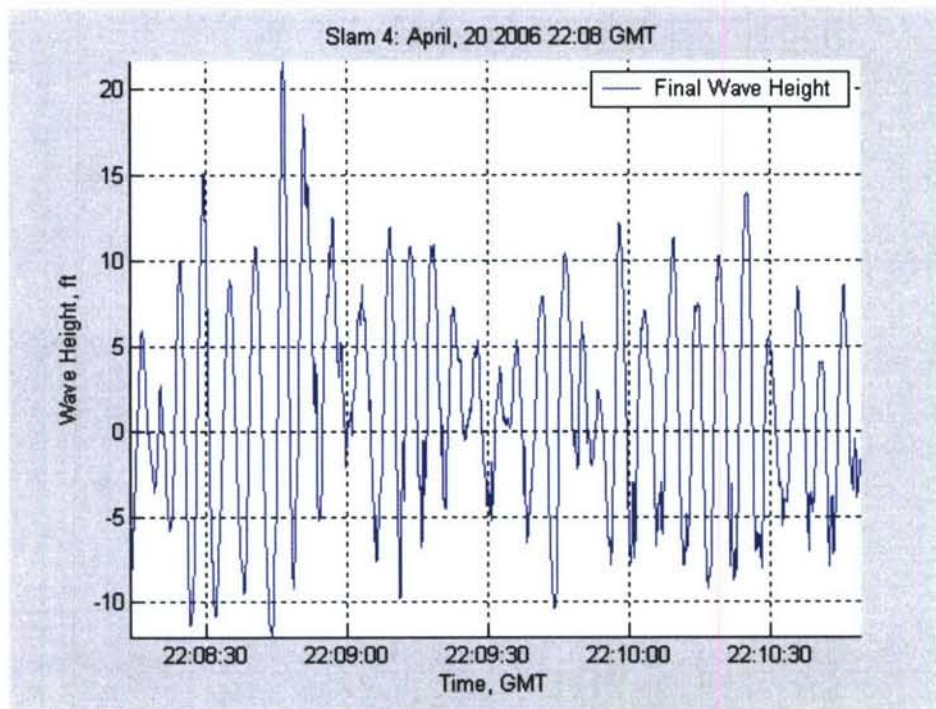
Figure C4. Slam Event 4: Final Wave Profile.
